Manhole Inspection Summary

Manhole # S31K__016MH

Insp Date: **11/23/08 11:17 AM**

Location Address: **Warner St**

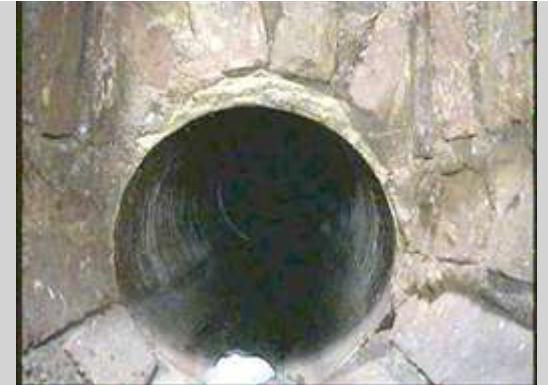
12 O'Clock Outflow

8 in. Circular Gravity Sewer
Pipe Out @ 12 O'Clock

Pipe Height: **8.4** (in.) Rod and Bar (Angled)
Pipe Material: **Clay** ☐ Pipe Lined
Invert Depth: **10.83** (ft.) Flow Characteristics: **Fast**
Deposits: ☒ None ☐ Mud ☐ Sludge ☐ Debris ☐ Grease
Silt Depth: **0** (in.) Deposits Extent:
Infiltration: **None** Pipe Seal Cond: **Sound**

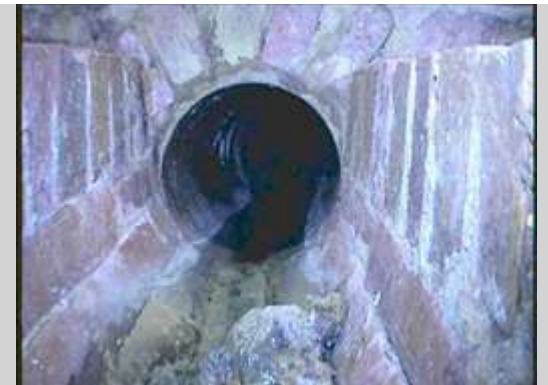
6 O'Clock Inflow

8 in. Circular Gravity Sewer
Pipe In @ 6 O'Clock

Pipe Height: **8.4** (in.) Rod and Bar (Angled)
Pipe Material: **Clay** ☐ Pipe Lined
Invert Depth: **10.53** (ft.) Flow Characteristics: **Slow**
Deposits: ☒ None ☐ Mud ☐ Sludge ☐ Debris ☐ Grease
Silt Depth: **0** (in.) Deposits Extent:
Infiltration: **None** Pipe Seal Cond: **Sound**

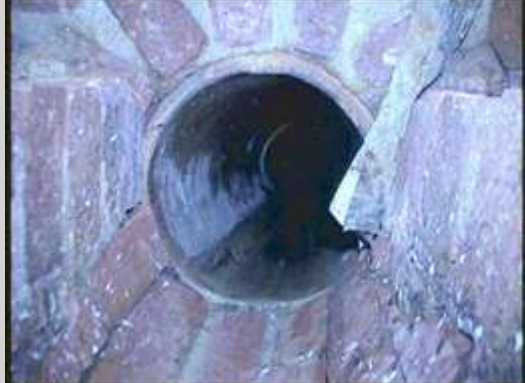
9 O'Clock Inflow

8 in. Circular Gravity Sewer

Pipe In @ 10 O'Clock

Pipe Height: **8.4** (in.) Rod and Bar (Angled)

Pipe Material: **Clay** ☐ Pipe Lined

Infiltration: **None** Pipe Seal Cond: **Sound**
